Docket No. 217 – Development and Management Plan Inspection

Northeast Utilities Service Company Certificate of Environmental Compatibility and Public Need for the construction of a 345-kV electric transmission line and reconstruction of an existing 115-kV electric transmission line between Connecticut Light and Power Company's Plumtree Substation in Bethel, through the towns of Redding, Weston, and Wilton, and to the Norwalk Substation in Norwalk, Connecticut.

Date: June 1, 2006

Location: Overhead Line (Composite 345kV and 115kV Gallows Hill to Archers Lane,
345kV H-Frame Hoyts Hill to Gallows Hill, and Norwalk Section)

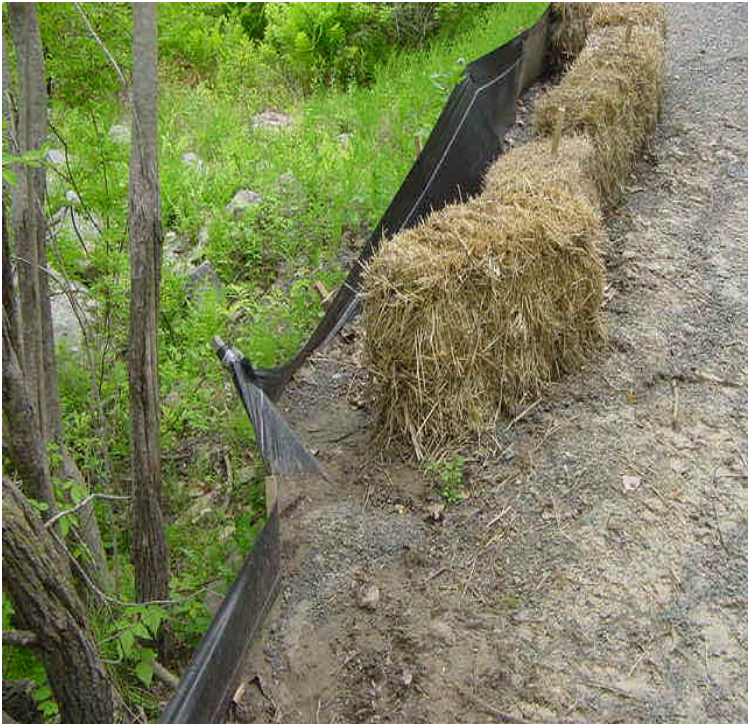
- A few spots along the access road in from Archers Lane have sediment nearly overtopping the silt fence. 6/1/06.	- Repairs should be made either by transition station or overhead crews. Sediment needs to be removed. 6/1/06.	-Needs attention- also see transition station report.
345kV H-Frame	- Other work areas are accessed from Hoyts	-Continue to monitor the conditions of all access	- N/A at this time

(Composite Section): Photo on the left shows an area of silt fence that was nearly overtopped along the access road in the ROW past Archers Lane. Photo on the right shows the wood chip area remaining on the ROW past Gallows Hill Rd. 6/1/06

Areas of Inspection	Observation	Recommended Action	Corrective Action
Erosion controls continued	overtopped in several places by sediment from run-off on the access road past Archers Lane. 6/1/06	repaired with silt pulled back and removed from the wetland. 6/1/06	either transition station or overhead crews

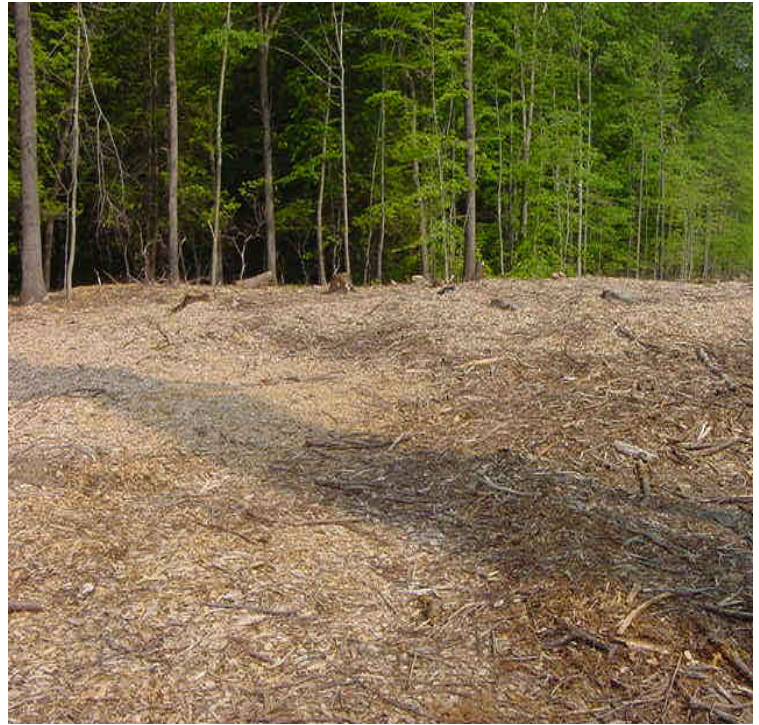
- Wood chips had been blown into the uplands and wetland area at the third structure in from Gallows Hill Road. 2/22-6/1/06. Another area with deep wood chips off the cleared ROW remains past Archers Lane. 3/15-6/1/06.	-Make sure chips stay on the ROW. Contractors should remove the off ROW chips since this is not allowed in the D&M plan. 2/22-6/1/06. - Wood chips on the ROW can remain at a depth of 3". Deeper piles should be spread out. 4/6-6/1/06.	-Still needs attention (CL&P is looking into a solution here)
345kV H-Frame Chestnut Ridge Section	- An old stockpile was noted at a structure before Rt 53 off Gallows Hill. 5/17-6/1/06	-Make sure that restoration occurs in previously disturbed areas and that materials are removed and not forgotten in place. 5/17-6/1/06	- Needs attention when feasible

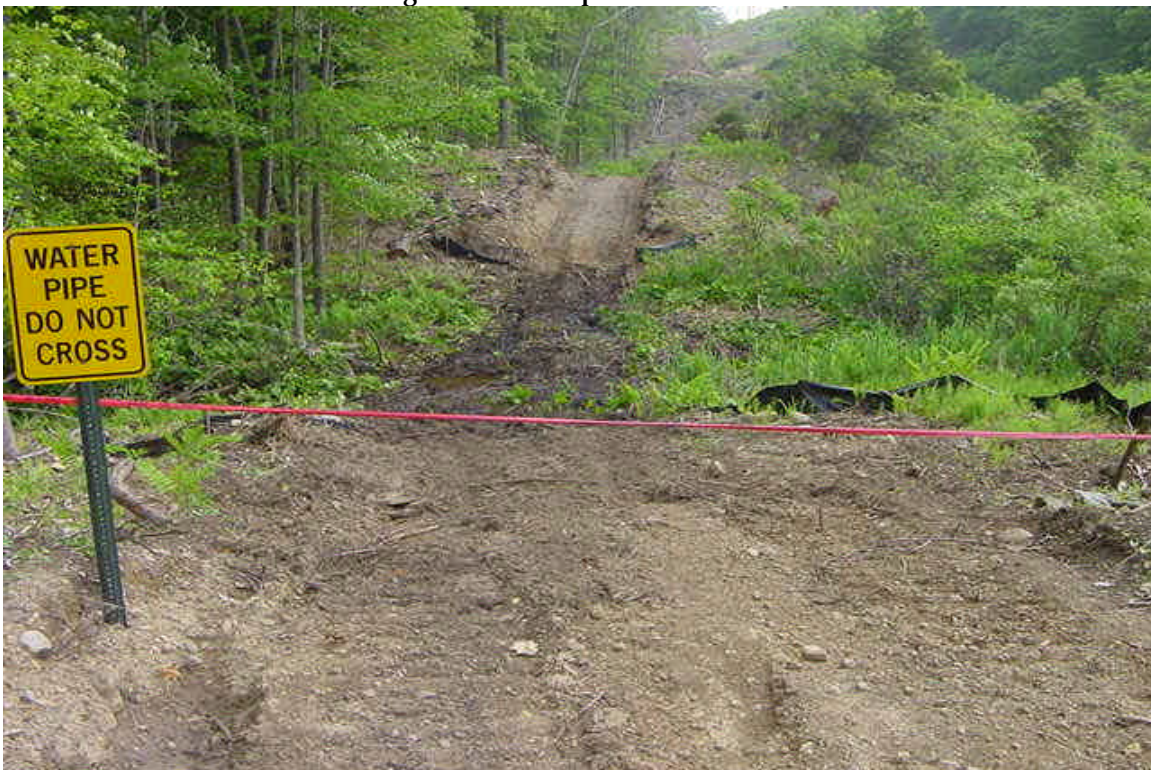
- All wetland crossings are still matted and in good shape. 6/1/06	- Continue to monitor. 6/1/06	-N/A
	- A vehicle accidentally drove through the wetland between poles #10-11 after mats were removed. Some ruts were created but the water main was not damaged. 5/25-6/1/06	- See erosion control section for more details but ruts should be smoothed out and additional controls installed. 5/25-6/1/06 A sign was installed to prevent further trips	- Needs attention

(345kV H-Frame): Photo on the left shows a view of the wetland between structures #10 and 11 with a sign installed to prevent further accidental crossings. Silt fence should be installed across the ROW on both ends and the surface restored where necessary. 6/1/06.

Areas of Inspection	Observation	Recommended Action	Corrective Action
<p>Costa Lane, Whortleberry, Lime Kiln and John Todd Way</p> <p>Norwalk Section</p>	- A vehicle accidentally crossed the stream & wetland between poles #10-11. Some ruts were created in the wetland. 6/1/06	-Any ruts in the stream or wetland should be smoothed out. (No damage to the water main had occurred.) 5/25-6/1/06	- Needs attention
	Disturbed soil remained on the access road adjacent to the wetland. 5/17-6/1/06.	Additional controls should be placed across the ROW to prevent sedimentation. 5/17-6/1/06	- Needs attention
	-Mats are in place at the wetland crossing in the vicinity of pole #29. 3/2-4/6-6/1/06.	-Continue to monitor the crossing for increasing muddy conditions and install silt fence as needed. 3/2-6/1/06.	-N/A at this time
	-Silt fence near structure #28 is being monitored and repaired as needed. 6/1/06.	-Continue to monitor .Wetlands are not located immediately adjacent. 6/1/06.	- Silt fence is being monitored

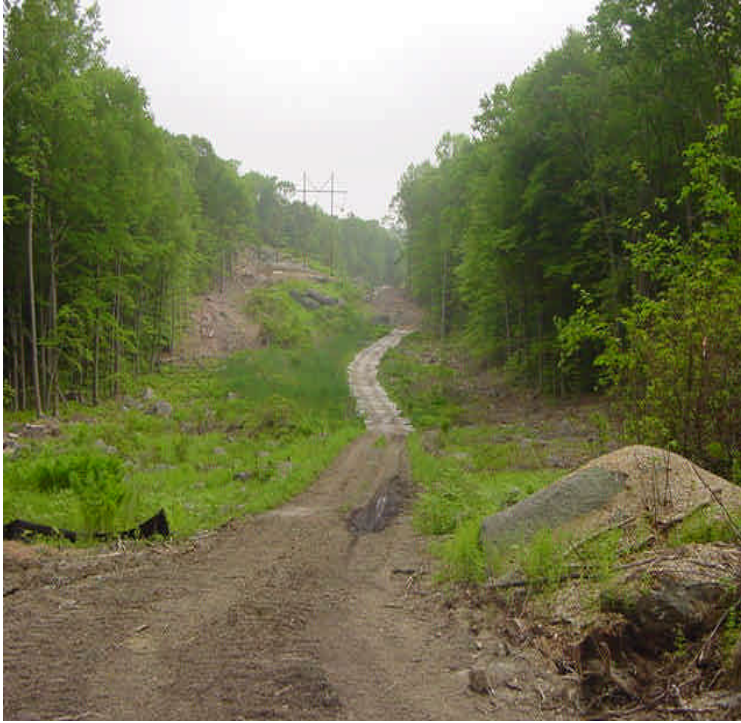
Photo on the left shows a view of the access road and a matted wetland crossing remaining in good shape in the Bethel Reservoir section. Photo on the right shows the matted wetland crossing also in good shape between structures #6-7. 6/1/06.

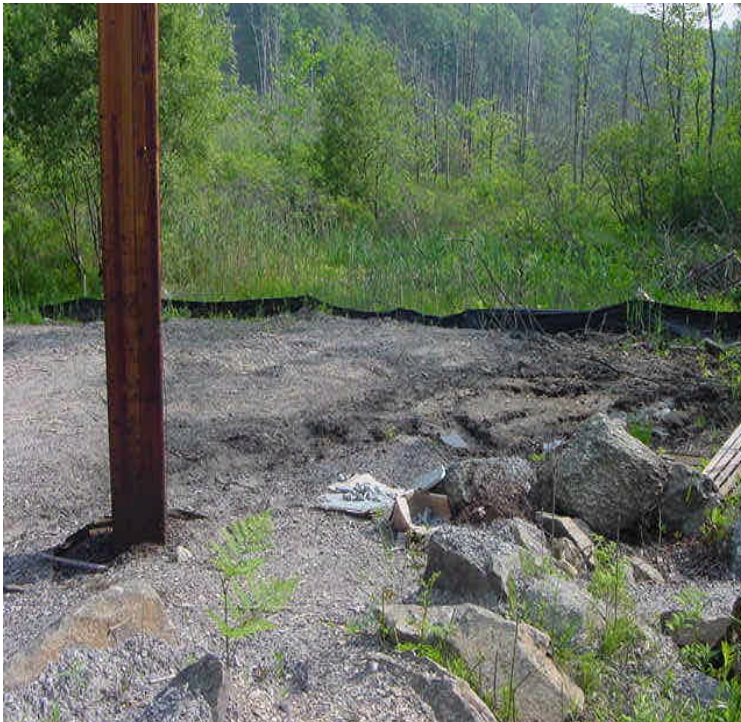
-Erosion controls remain intact at poles #24 and 25 and further washouts were not noted. 6/1/06.	-Maintain controls until areas surrounding the foundation are stabilized. 6/1/06	-N/A
	-The area of silt fence south of Perry Ave. had sediment piled up against it again. 6/1/06.	-The fence has been monitored and regularly cleaned out but this is needed again. 6/1/06.	-Needs attention again

Photo on the left shows the erosion controls in good shape adjacent to the large wetland near structure#24. Photo on the right shows crews installing shield wire on a structure off Costa Lane. 6/1/06.

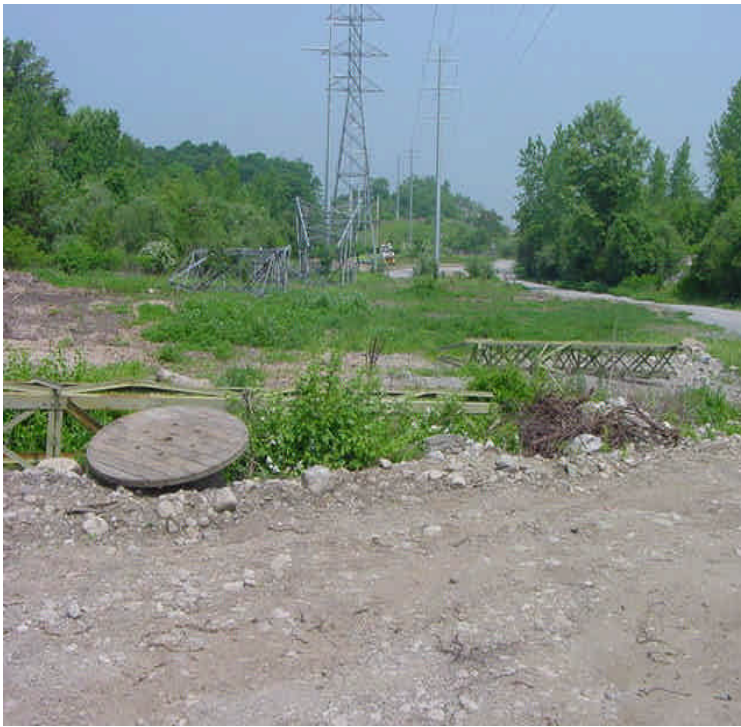
- No active work was noted between Perry Ave. and the Rt 7 extension but old towers had been taken down south of Perry Ave. 6/1/06.	-See erosion controls section for more information. 6/1/06.	-N/A

(Norwalk Section): Photo on the left shows towers being removed in the Perry Ave area. Photo on the right shows where sediment continues to overtop the silt fence in this area. Crews regularly monitor the fence and pull the silt back. 6/1/06.

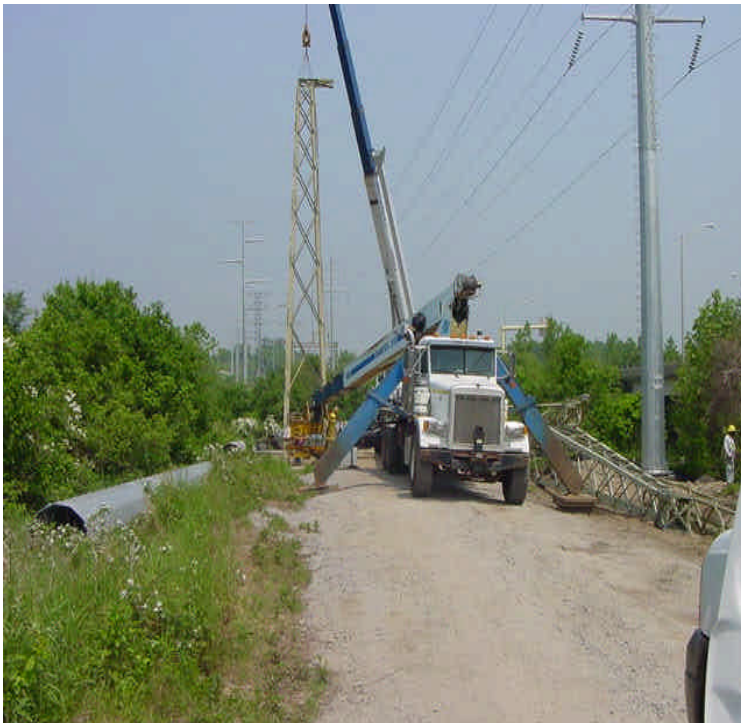
Photo on the left shows a structure being removed in the area north of Broad St.. Photo on the right shows a foundation installation off North Seir Hill Rd. where mats had to be used due to wet, muddy conditions. Install fence downgradient of the mats if necessary. 6/1/06

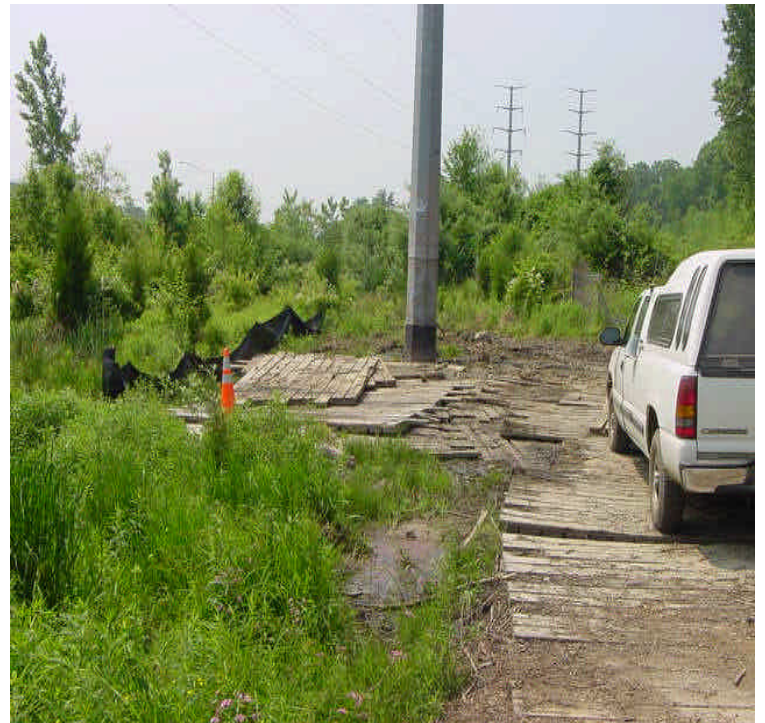
- Mats were installed at foundation #68 on North Seir Hill Rd. due to wet conditions. 6/1/06	-Install silt fence downgradient of the mats if necessary. 6/1/06.	-Mats were used to prevent ruts.

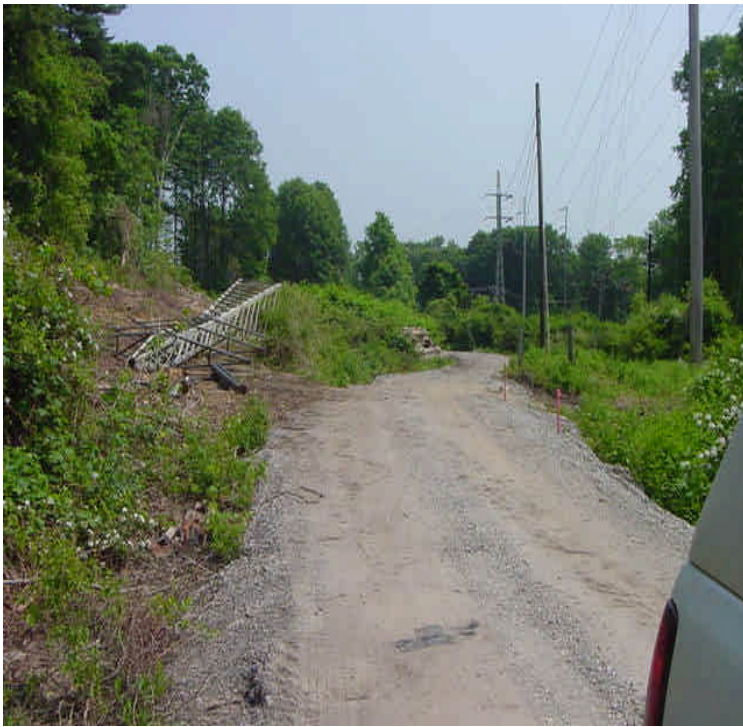
- Old towers were taken down south of Kent Rd. 6/1/06	- None at this time.	- N/A
	- Access road construction was complete up to the pond in the new ROW section off Kent Rd. 6/1/06	- See erosion controls section for more information. 6/1/06	- N/A
Erosion and Sediment Controls	- Water levels appear to remain below problem levels at the 2 nd wetland crossing along the Archers Lane access road. 2/16-6/1/06.	- None at this time. 6/1/06.	-N/A
Composite	- Silt fence is being	-All areas should be	- Needs attention from

Photo on the left shows an access road within the ROW off Kent Rd. Old towers were being removed in this location. Photo on the right shows a view of the clearing occurring off Kent Rd. in the new ROW. 6/1/06

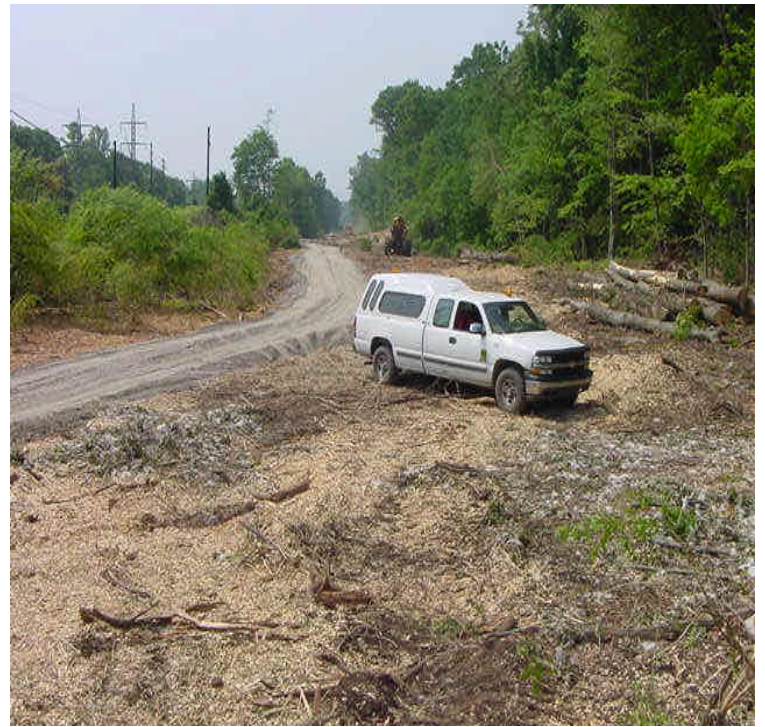
Areas of Inspection	Observation	Recommended Action	Corrective Action
	<p>6/1/06.</p> <ul style="list-style-type: none"> - Clearing of new ROW is underway in the Kent Rd. section and it has reached the bank of the pond in the area. 6/1/06 - Efforts were made to retain stumps along the bank but adjacent homeowners have mentioned branches falling into the water. 6/1/06 	<ul style="list-style-type: none"> - Be extremely careful to retain shrubs and vegetation where feasible. 5/25-6/1/06 - Make all attempts to retain vegetation at the bank and to collect branches. 	<ul style="list-style-type: none"> - Needs some improvement in the new section even though the majority of shrub species present are invasive
Dewatering	<ul style="list-style-type: none"> - No obvious dewatering efforts were noted. 6/1/06. - If this is needed by foundation #68, make sure controls are installed due to the proximity of wetlands. 6/1/06 	<ul style="list-style-type: none"> - Release water to the ground only in well vegetated areas if it will not reach any resource areas. (Make sure to check downgradient for these areas) Otherwise use a filter bag or adequate containment. 3/9-6/1/06. 	-N/A at this time

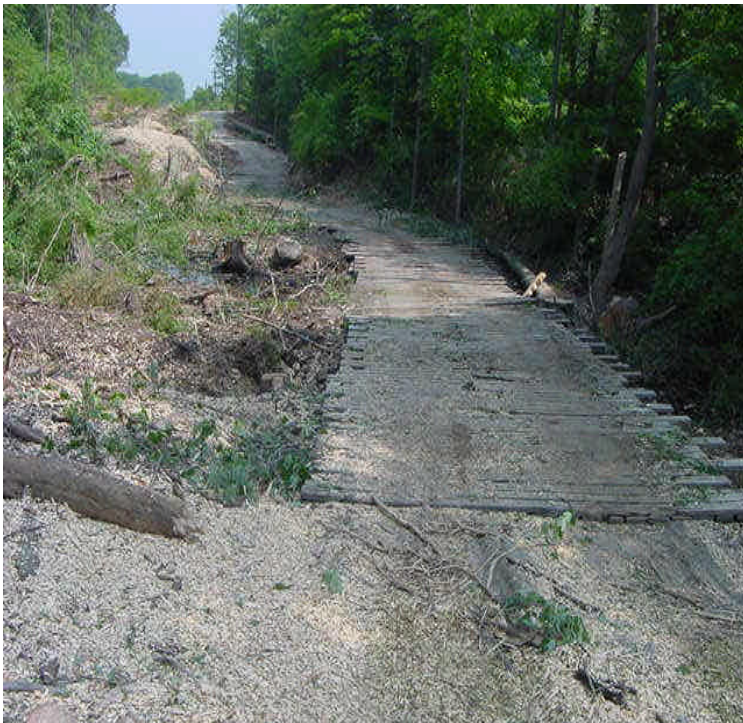
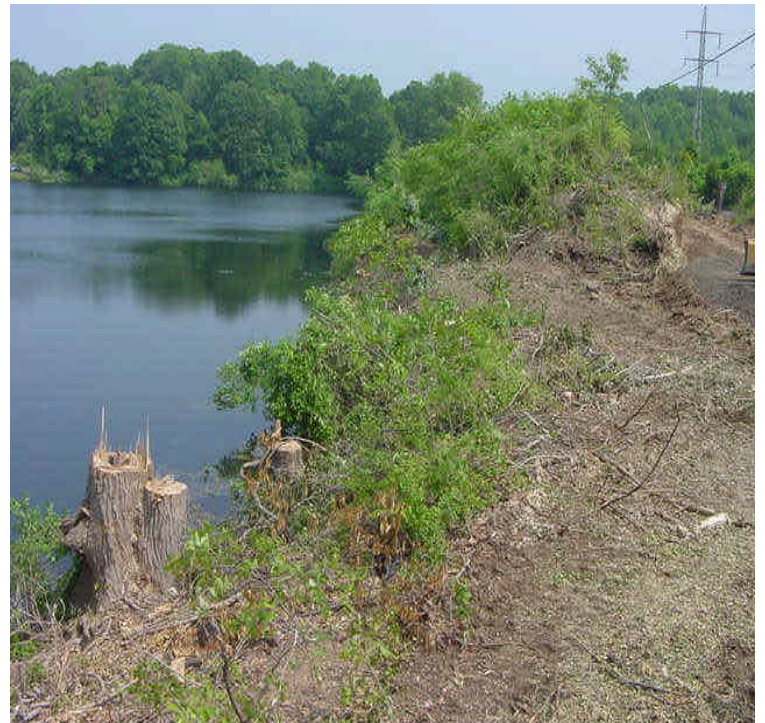
- A new wetland crossing in the Kent Rd, new ROW section, was noted without corner controls. 6/1/06	-Haybales or silt fence will be installed at the corners of the mat crossings to prevent runoff from the access	-Needs attention.

Photo shows the mats installed for a wetland crossing in the section of new ROW. Silt fence should be installed at the corners and care has to be made to avoid blowing wood chips into the wetland. Photo on the left shows the clearing adjacent to the pond. Crews attempted to retain stumps on the bank. 6/1/06
